EXHIBIT "A" - PHOTOS

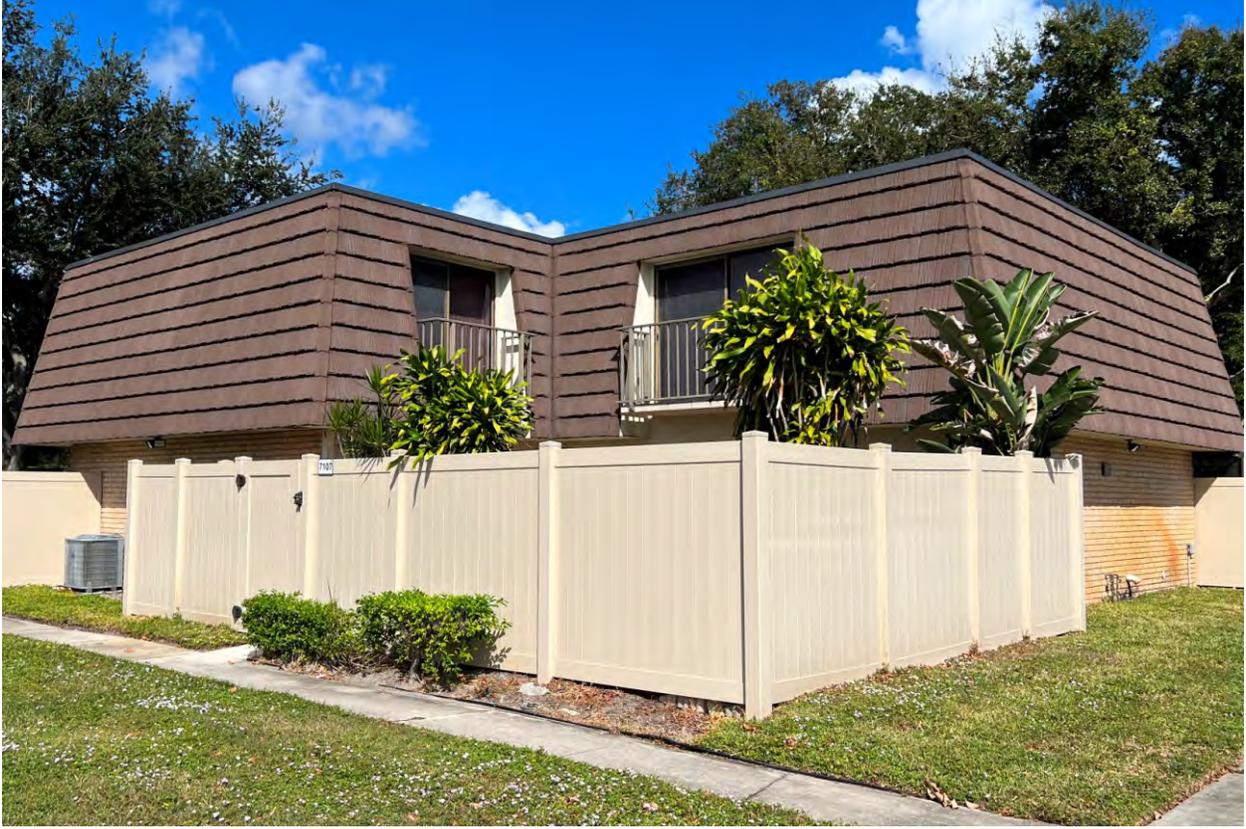
TYPICAL UNIT

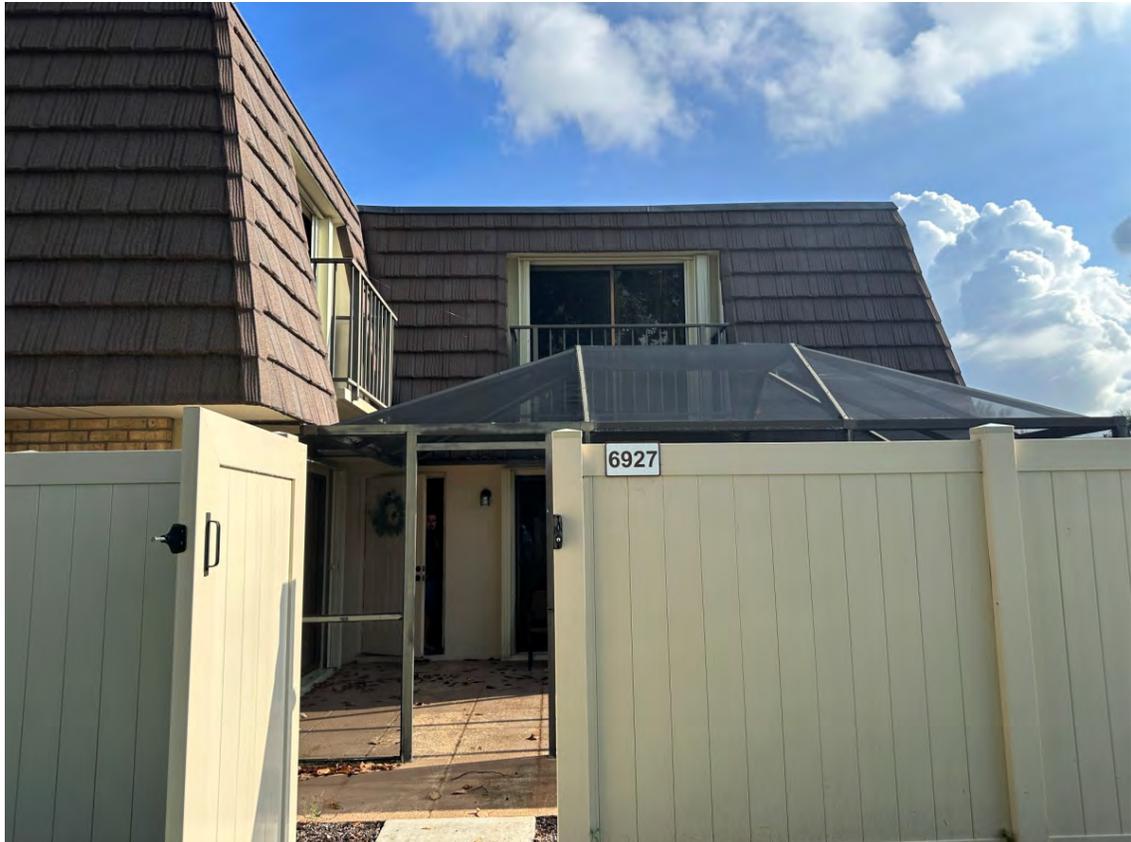
TYPICAL UNIT WITH SCREEN ENCLOSURE

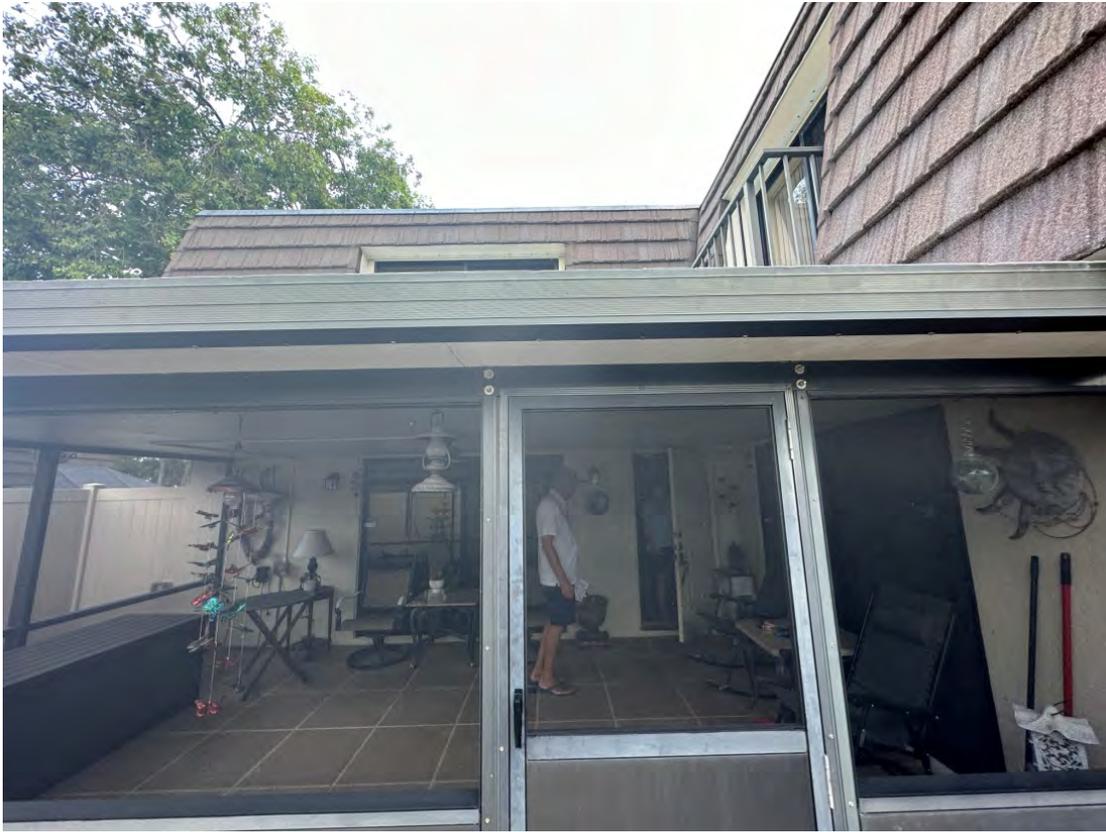
TYPICAL UNIT WITH COVERED FLAT SCREEN ENCLOSURE

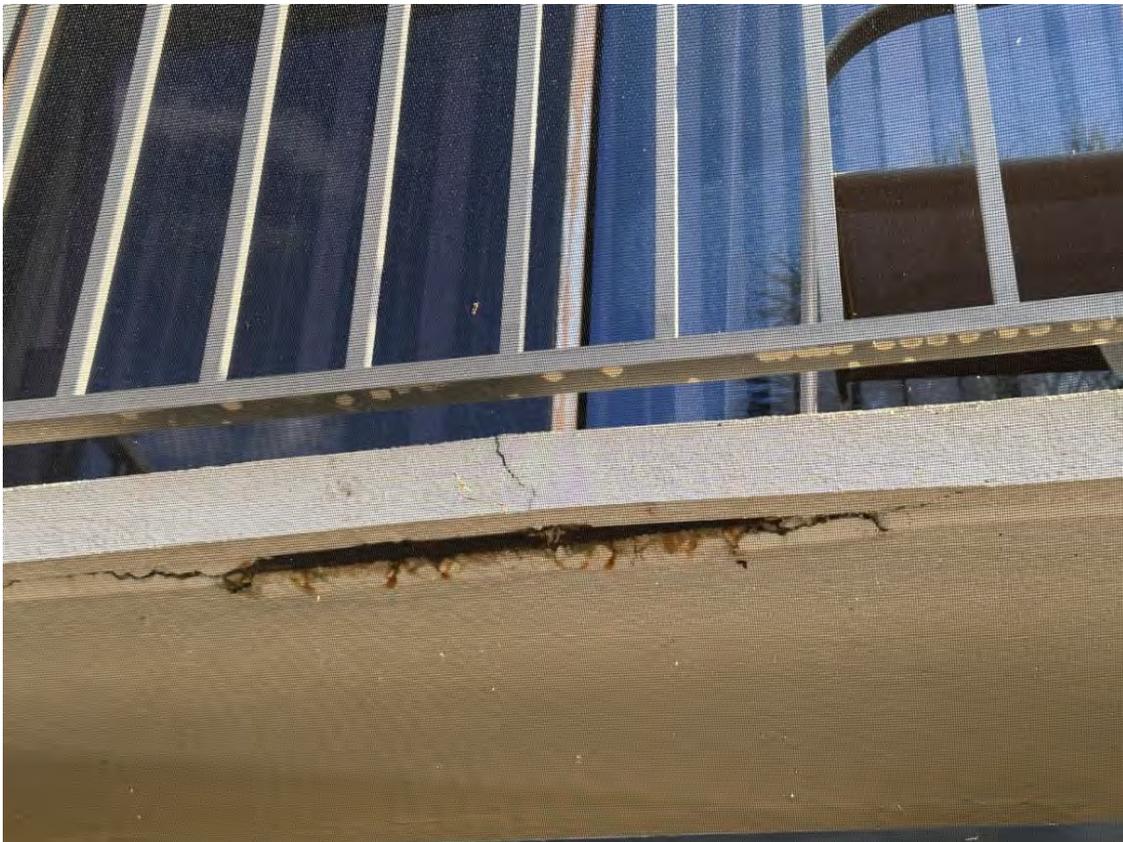
BALCONY SLAB EDGE SPALL WITH EXPOSED REBAR

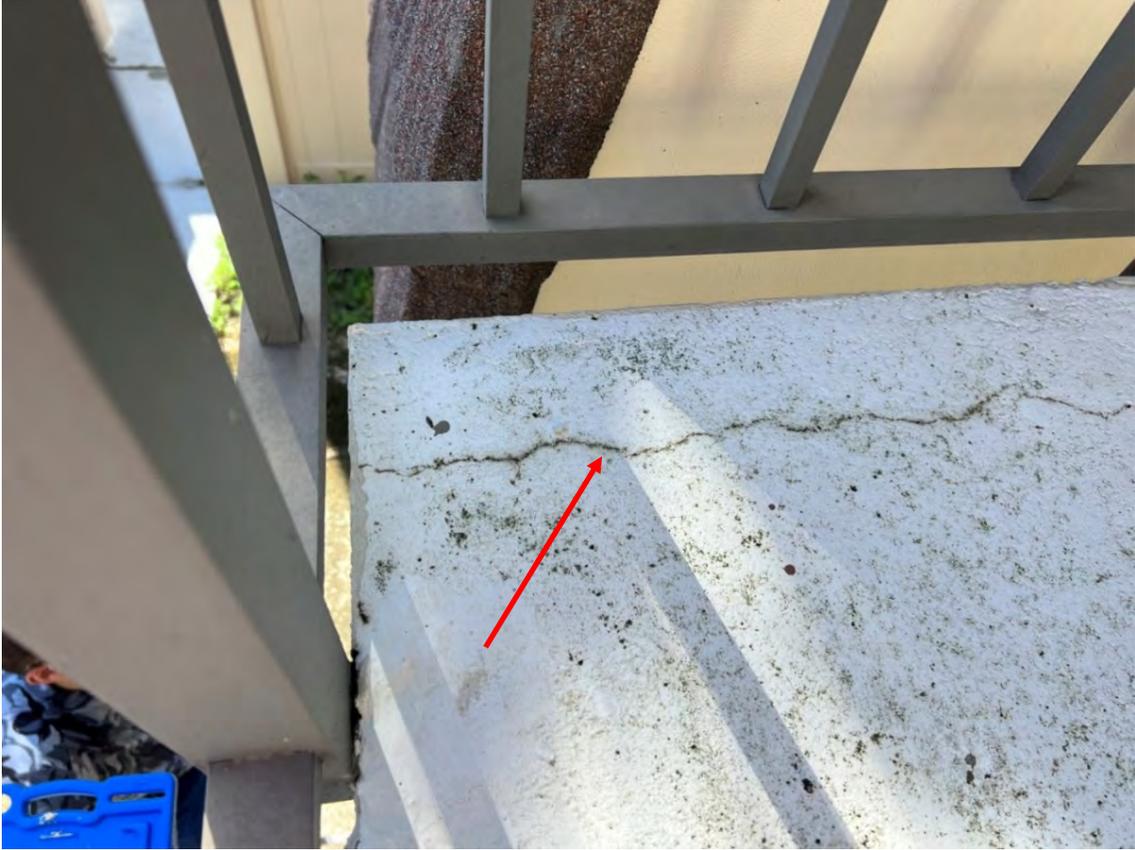
BALCONY SLAB EDGE SPALL

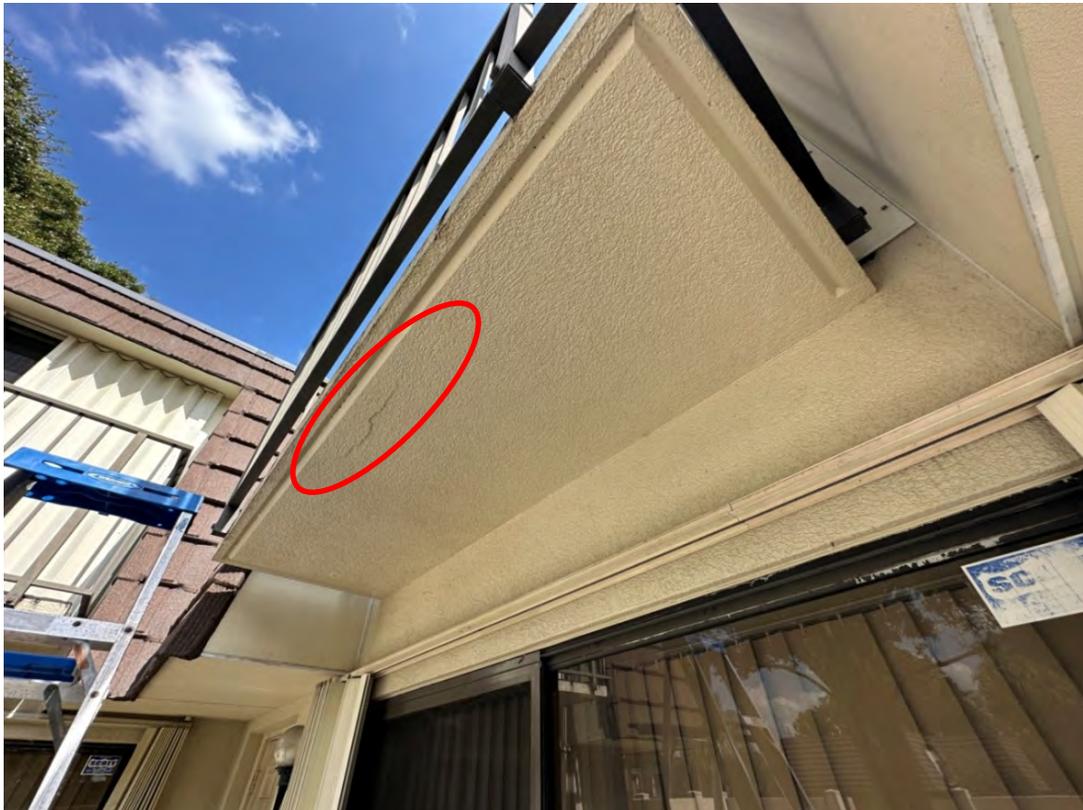
BALCONY CEILING SLAB SPALL

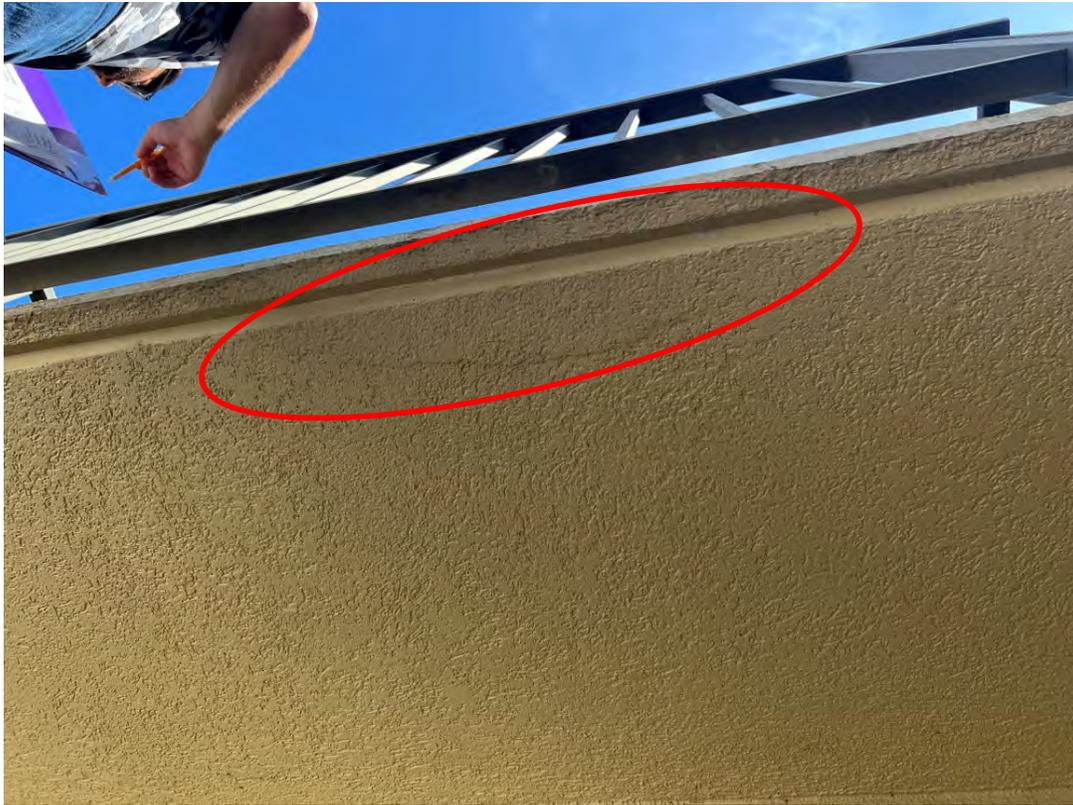
BALCONY CEILING SLAB SPALL

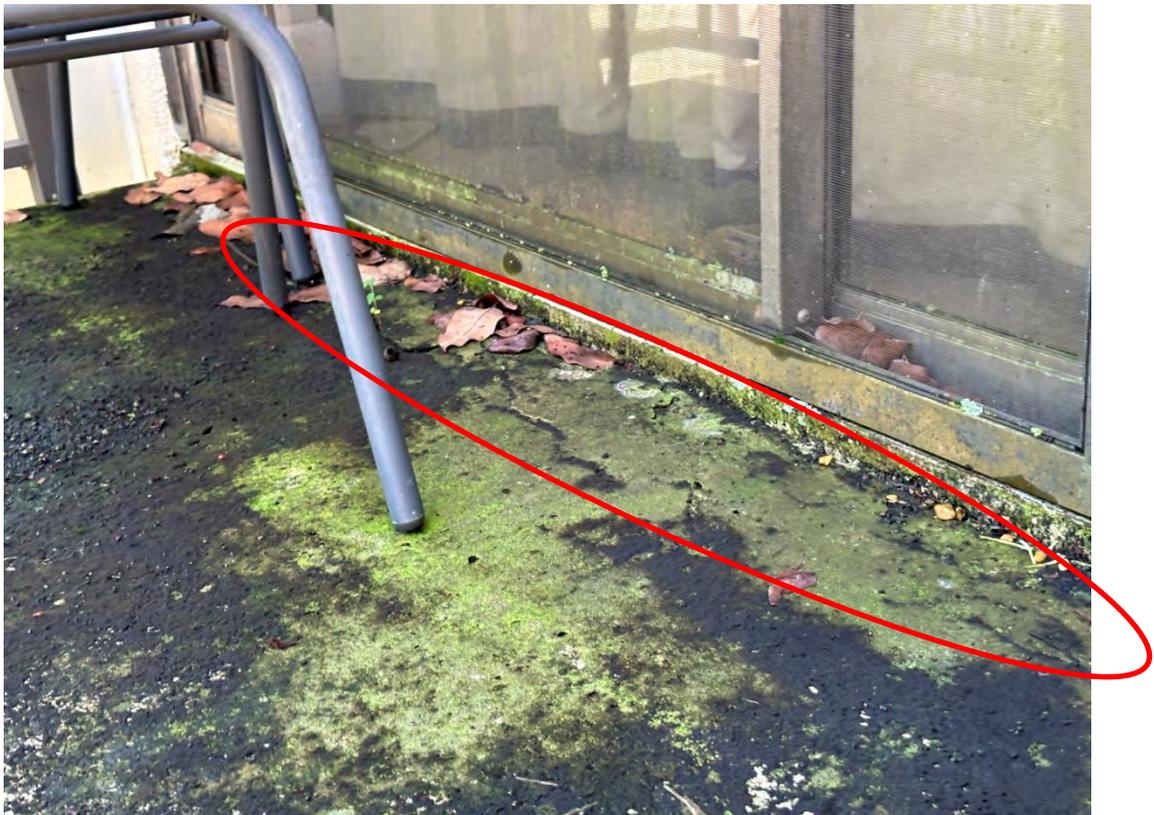
BALCONY SLAB SPALL NEAR SLIDING GLASS DOOR

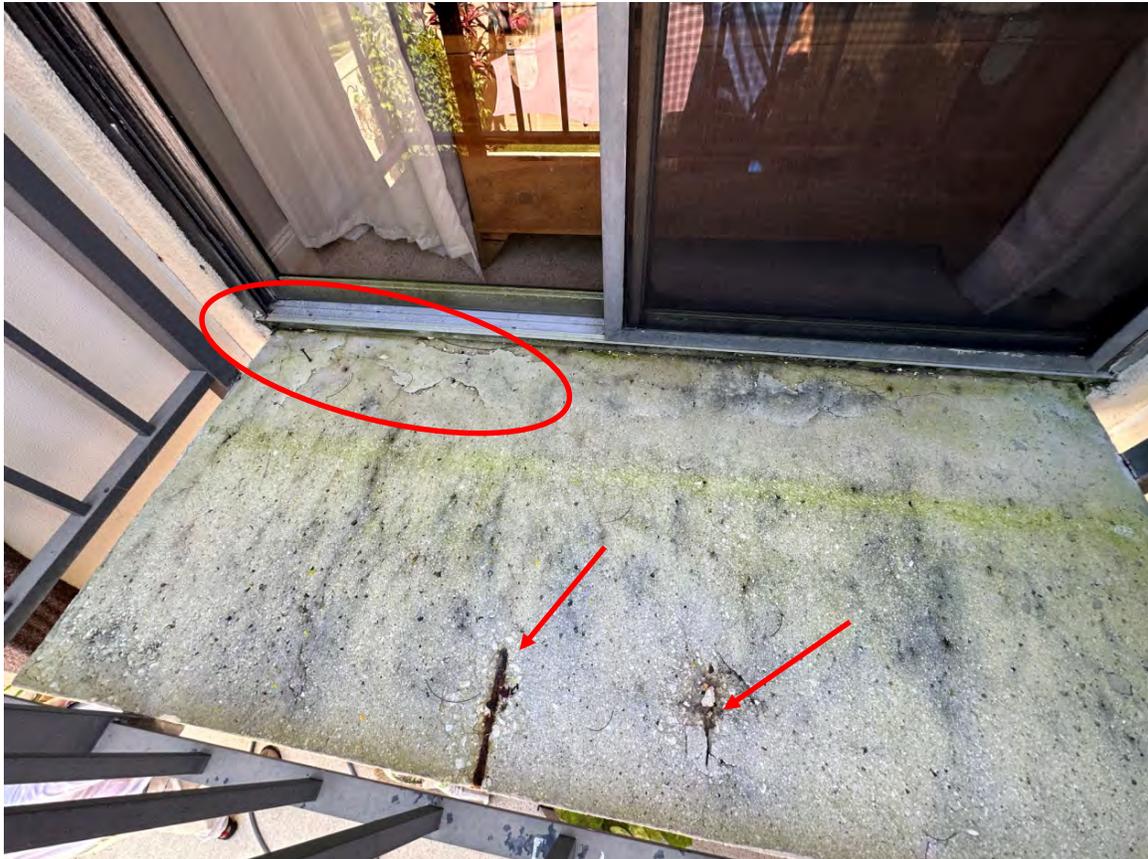
BALCONY SLAB SPALLS AND EXPOSED REBAR

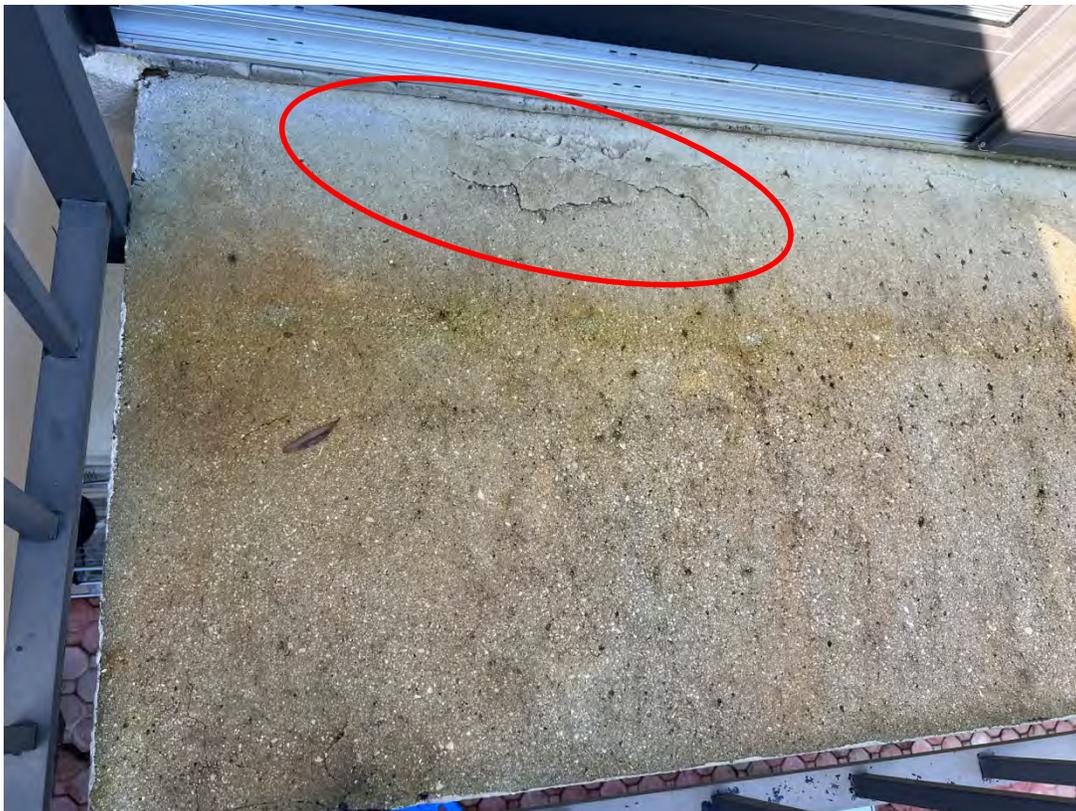
SLAB SPALL NEAR SLIDING GLASS DOOR

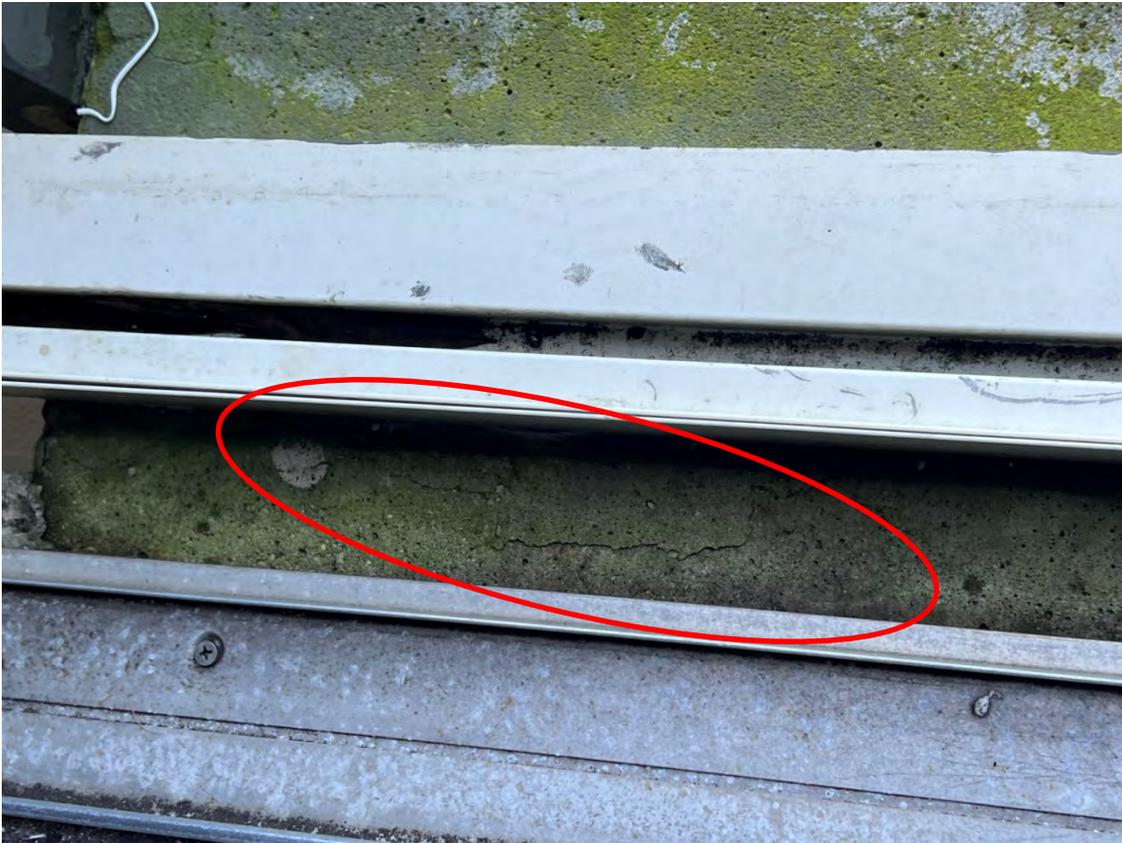
SPALL BETWEEN SHUTTER TRACK AND SLIDING GLASS DOOR

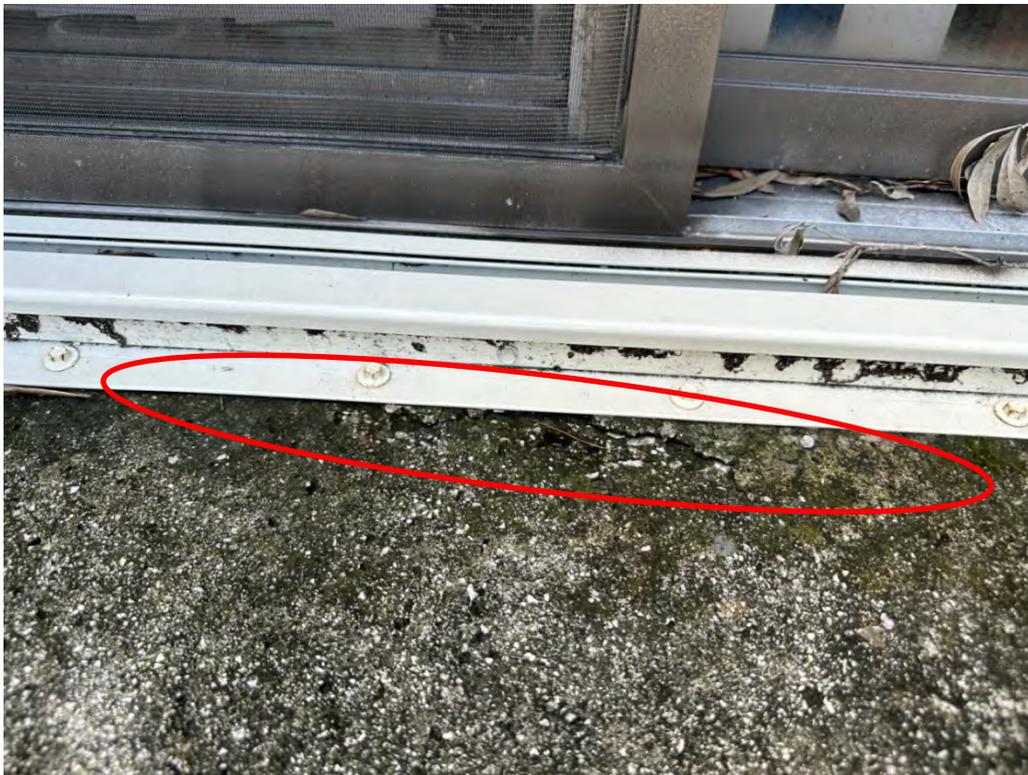
SPALL UNDER SHUTTER TRACK

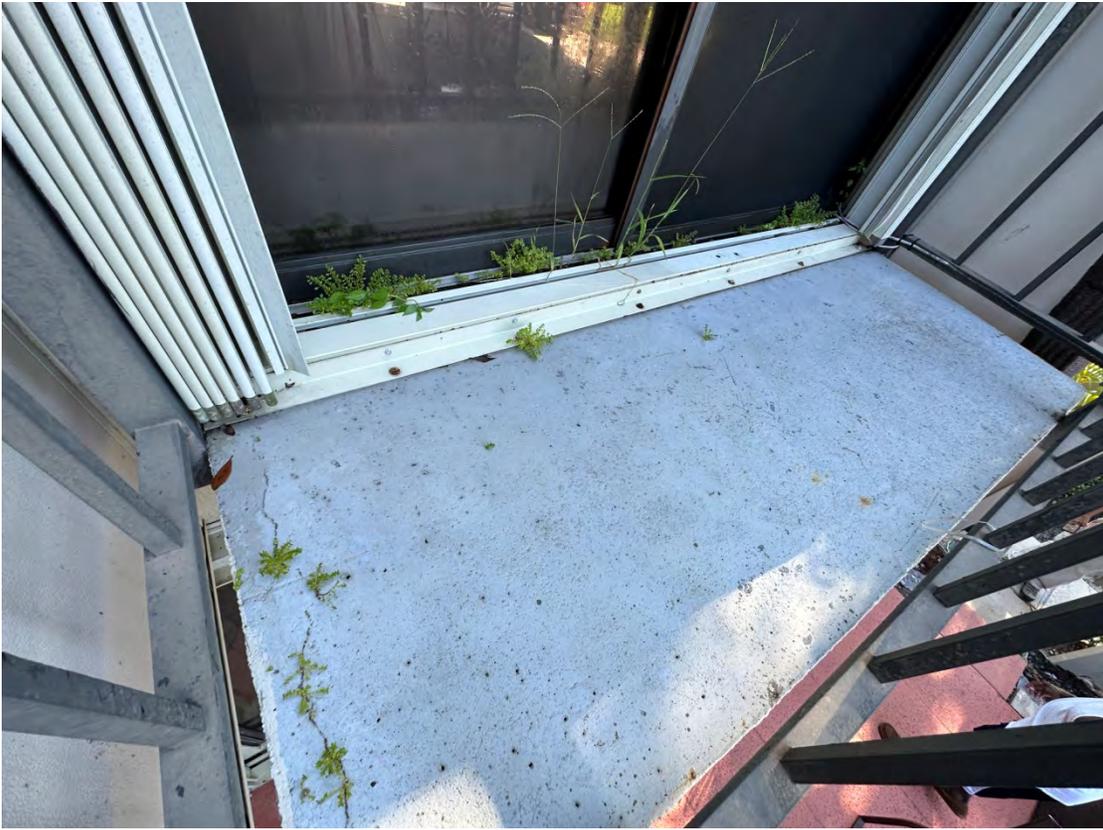
SLAB EDGE SPALL AND VEGETATION

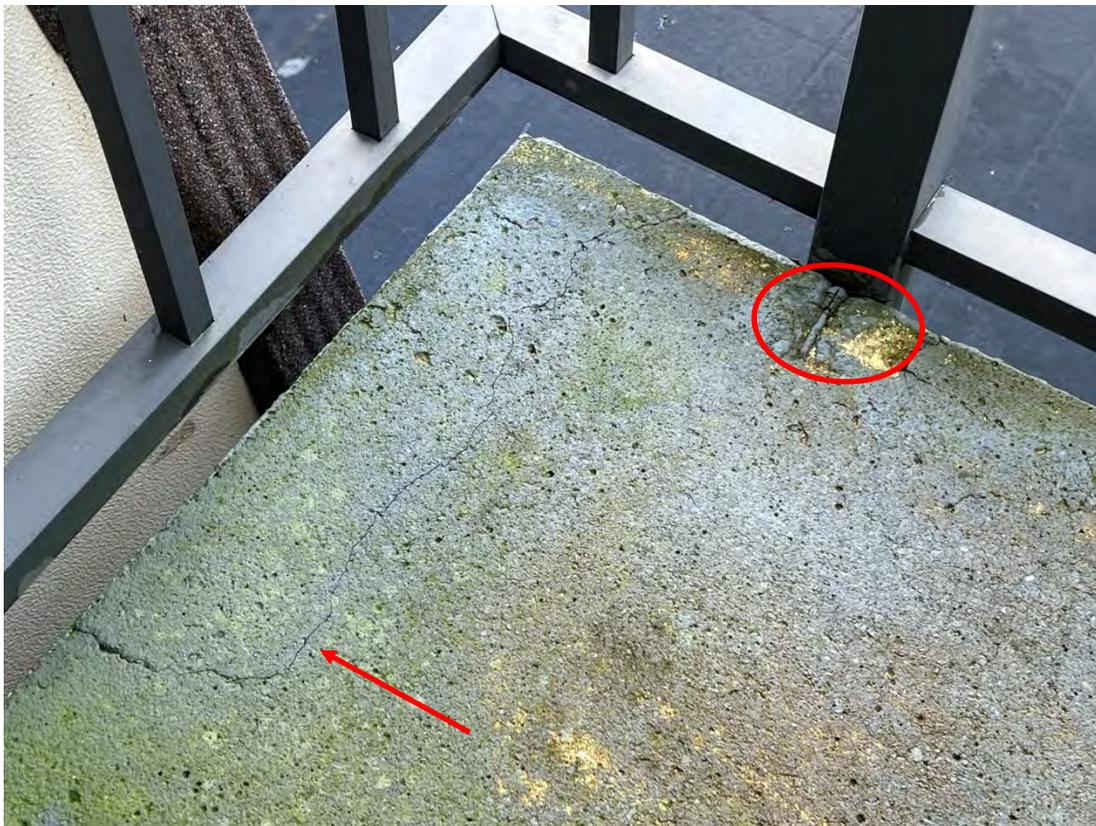
BALCONY SLAB EDGE SPALL AND EXPOSED RAILING BOLT

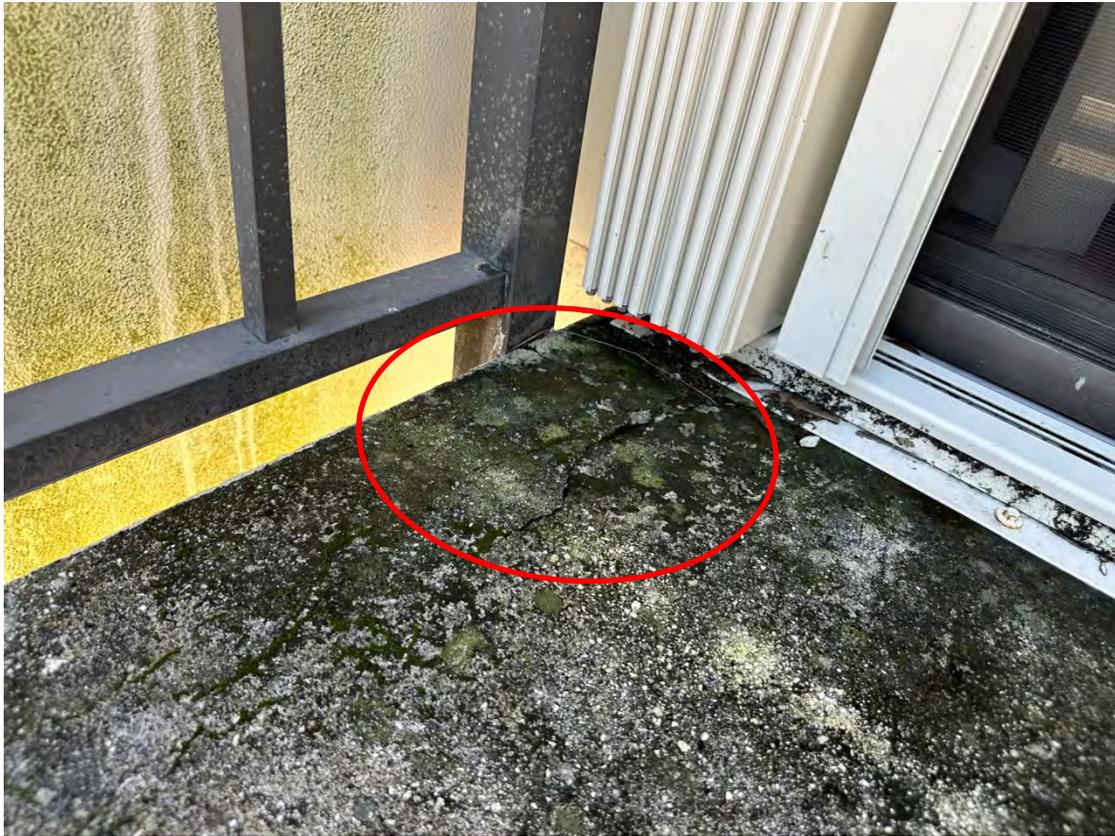
BALCONY SLAB SPALL NEAR RAILING BOLT

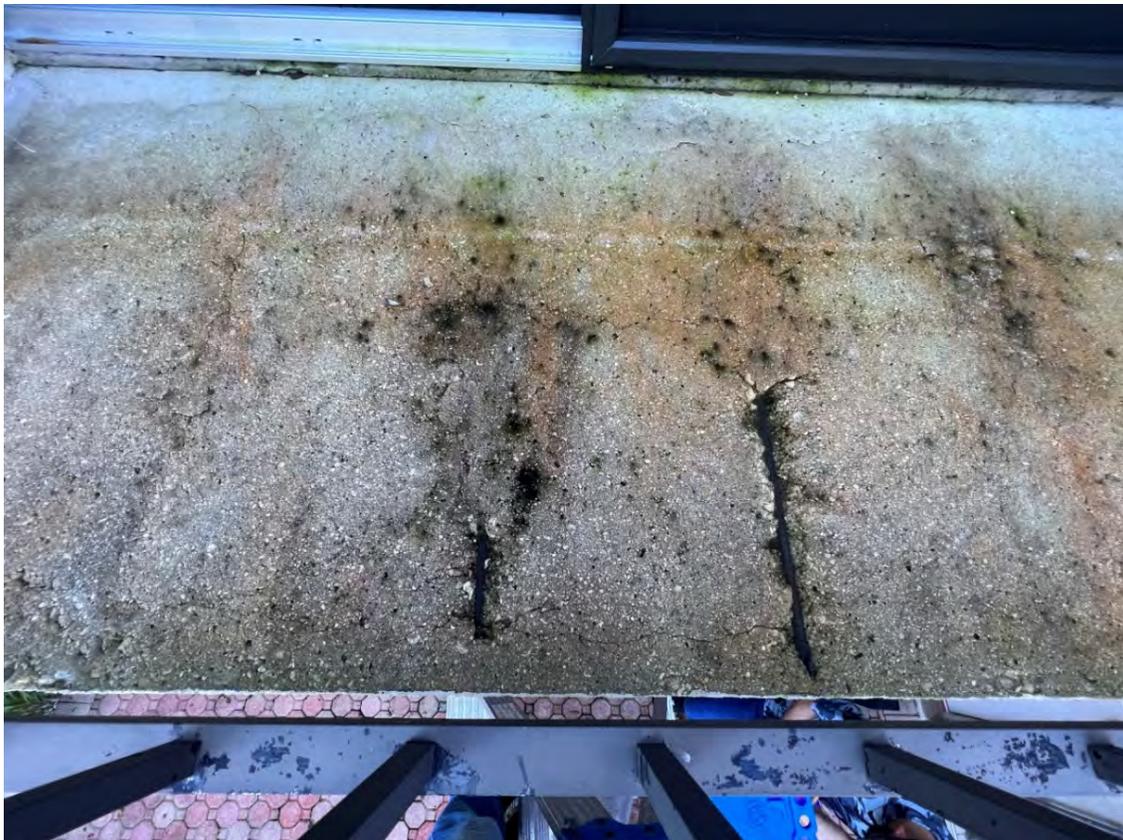
EXPOSED REBAR ON BALCONY

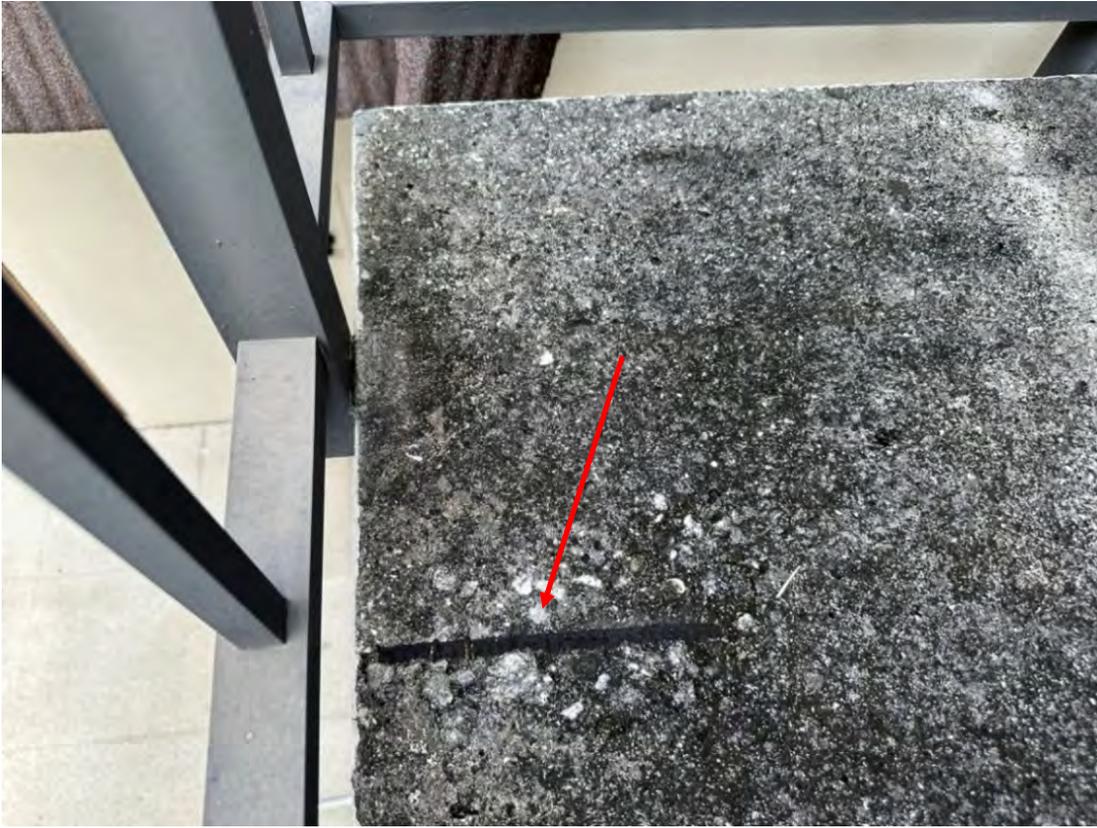
EXPOSED REBAR ON BALCONY

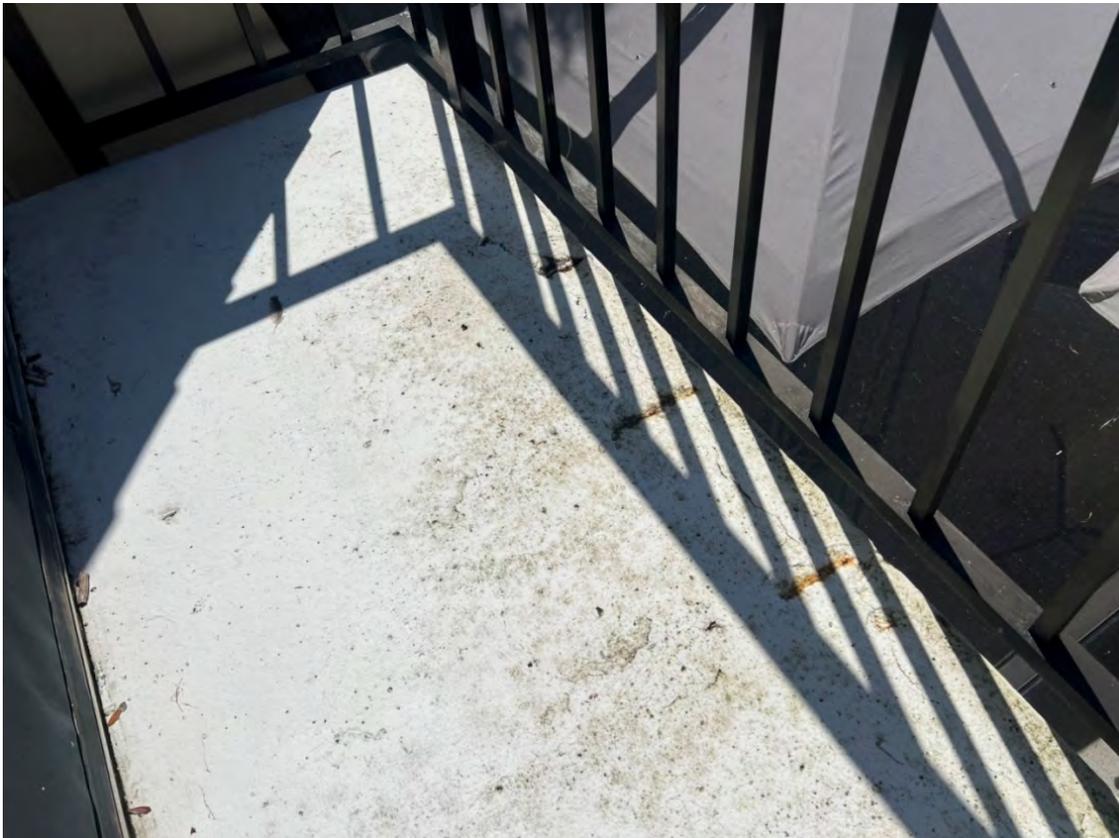
EXPOSED REBAR ON BALCONY

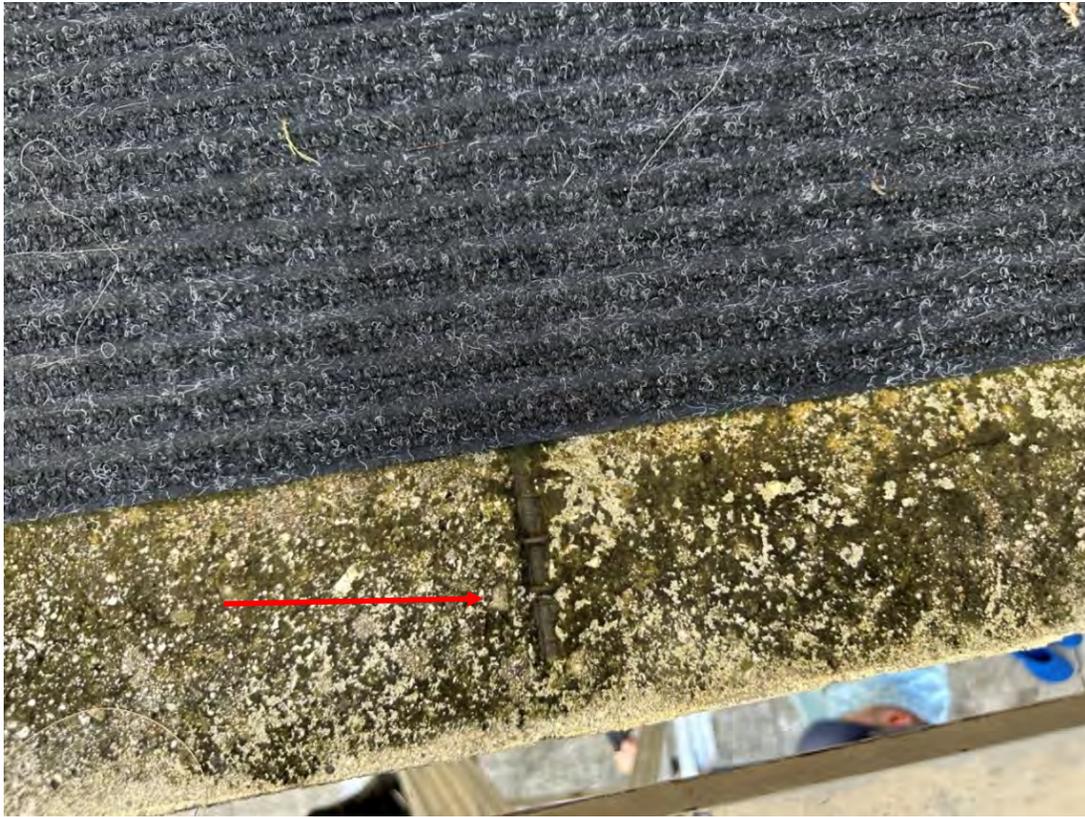
EXPOSED REBAR ON BALCONY

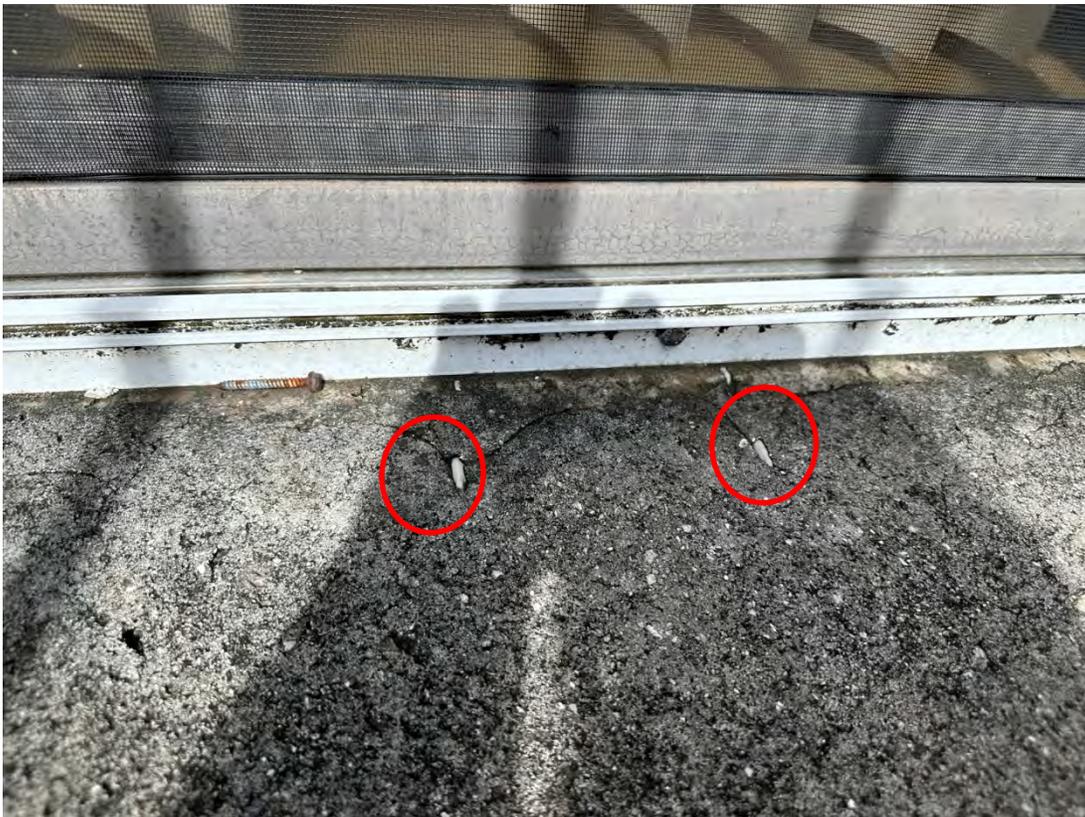
SLAB SPALL AND EXPOSED CHAIR TIPS

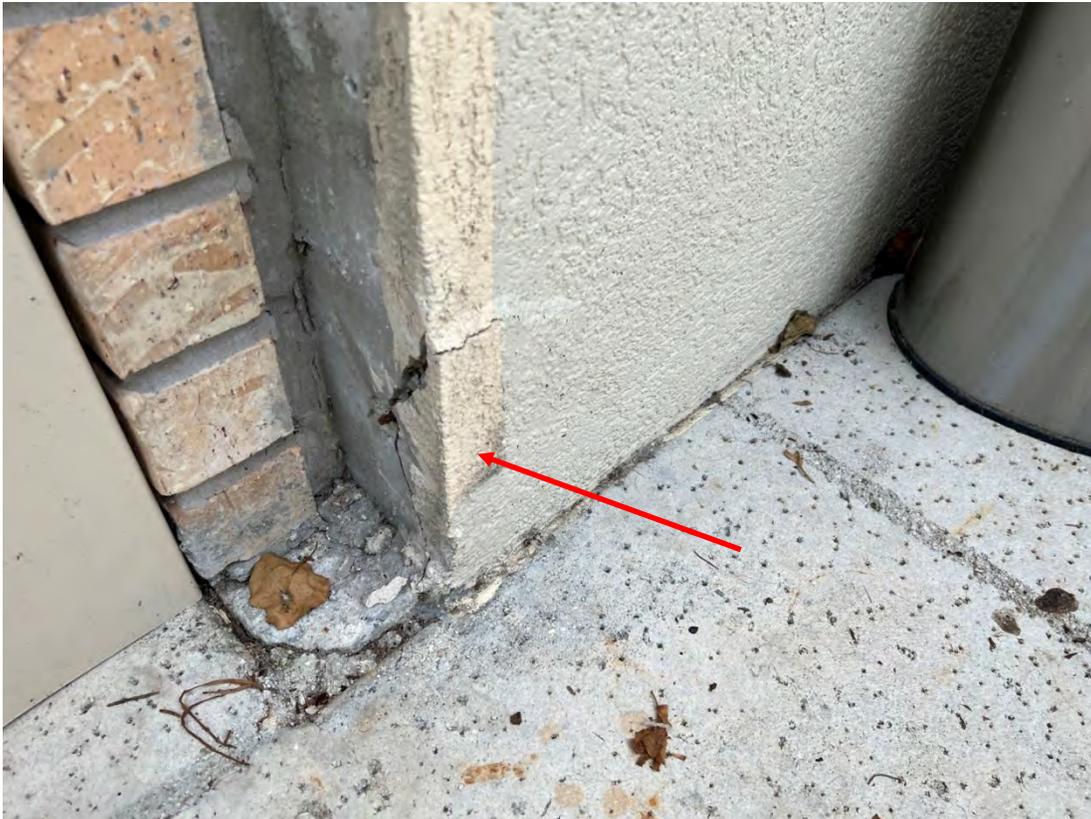
WALL SPALL

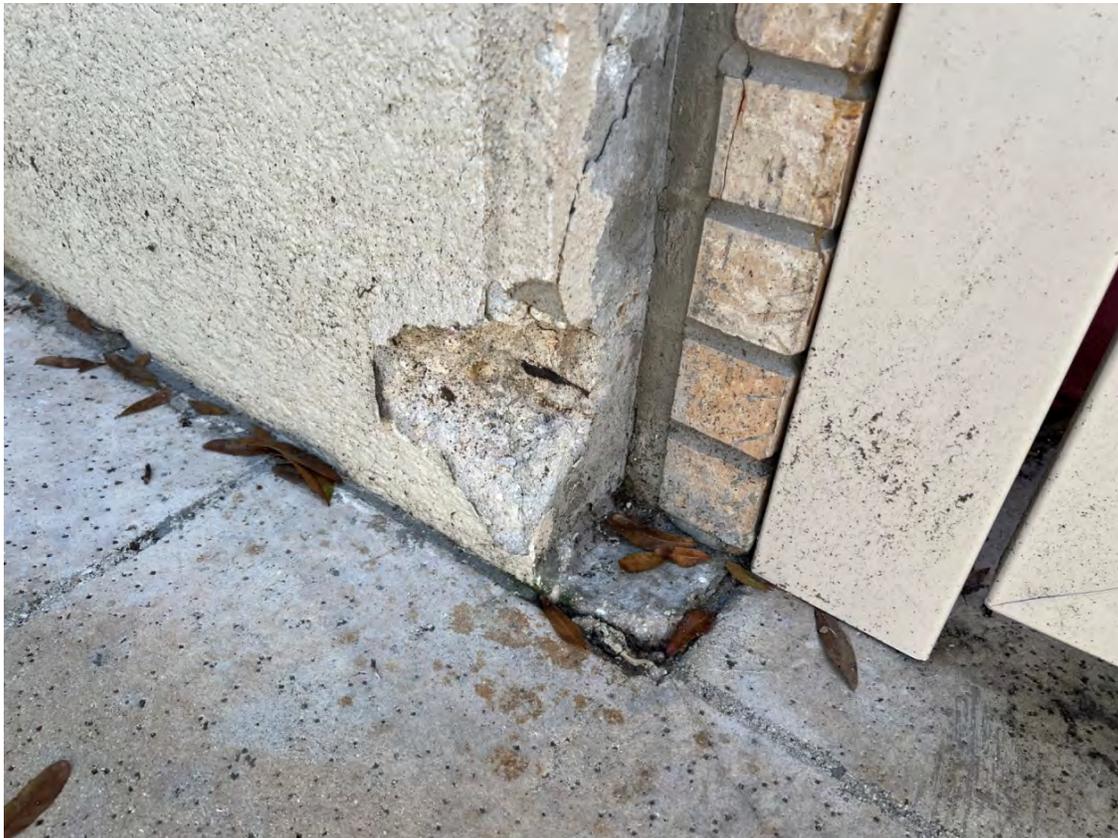
WALL SPALL WITH EXPOSED REBAR

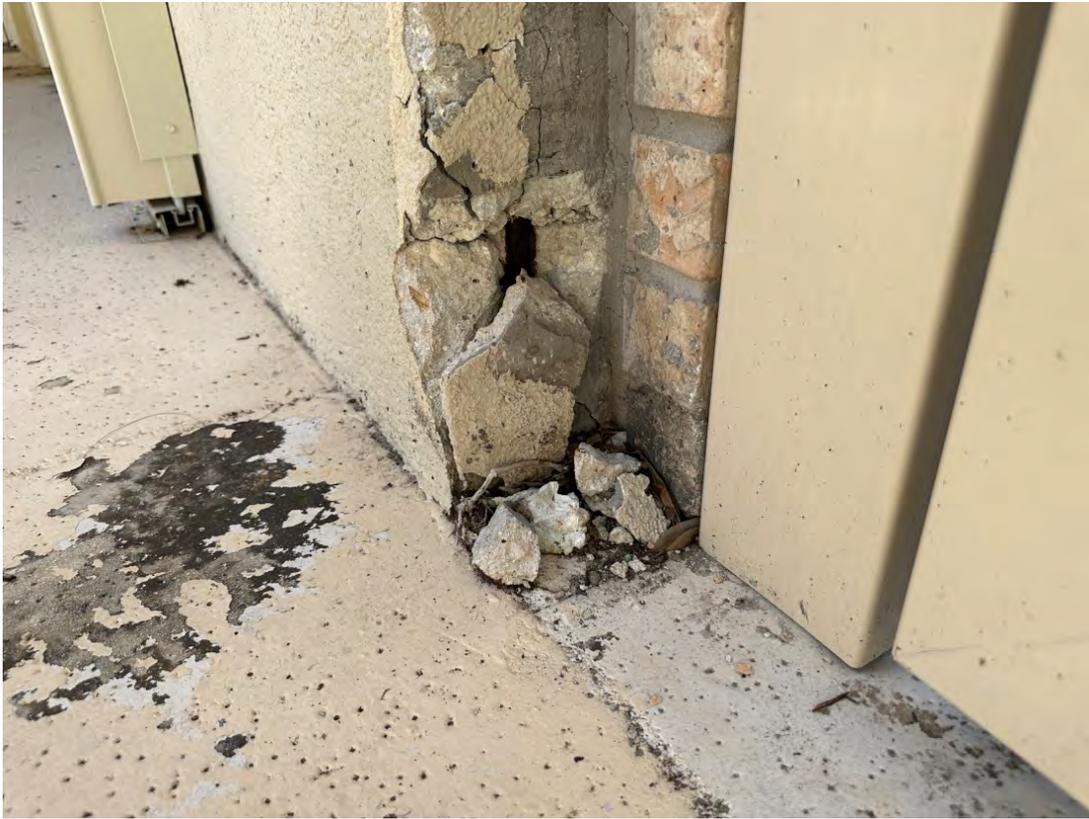
WALL SPALL WITH EXPOSED REBAR

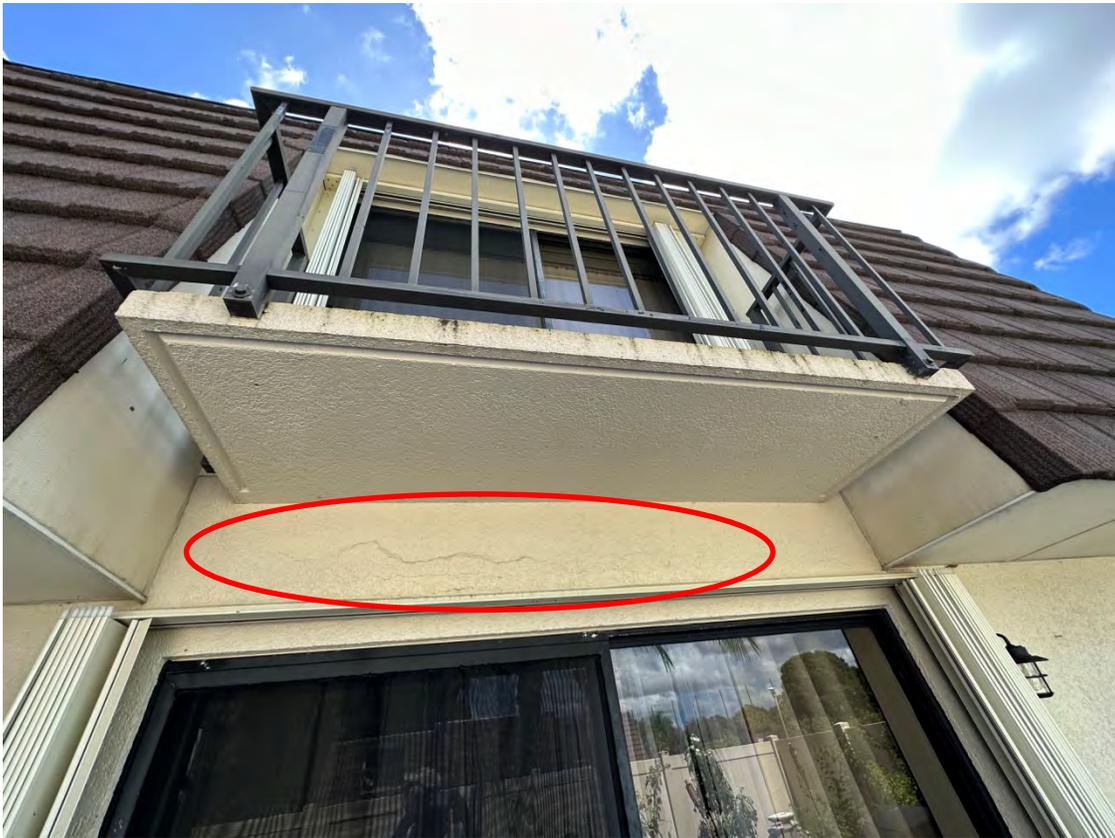
BEAM SPALL

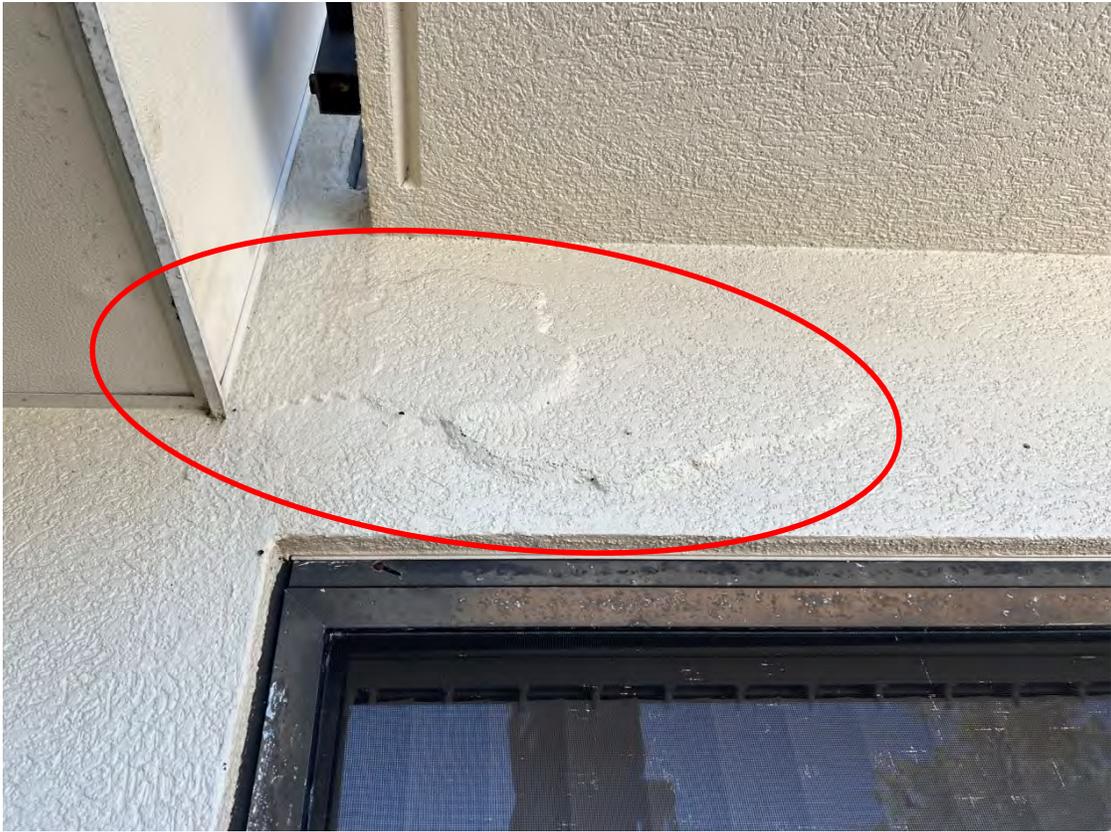
BEAM SPALL
