EXHIBIT "A" - PHOTOS

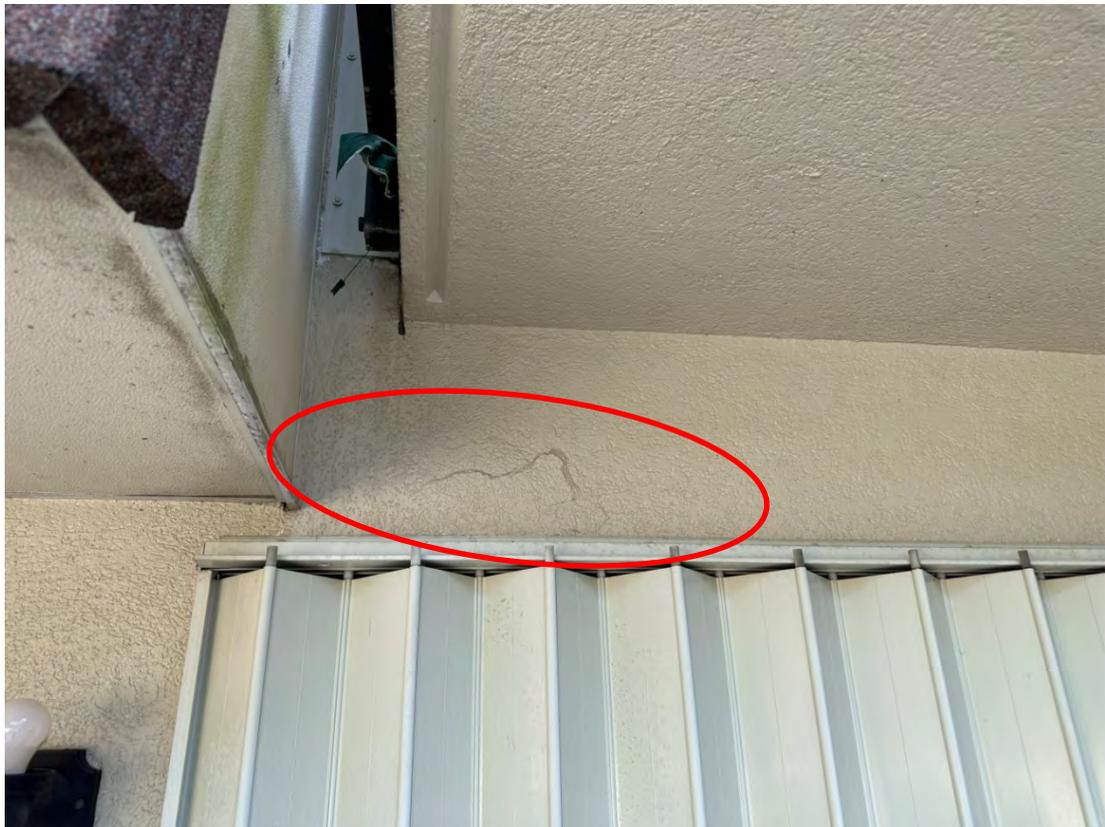
BEAM SPALL

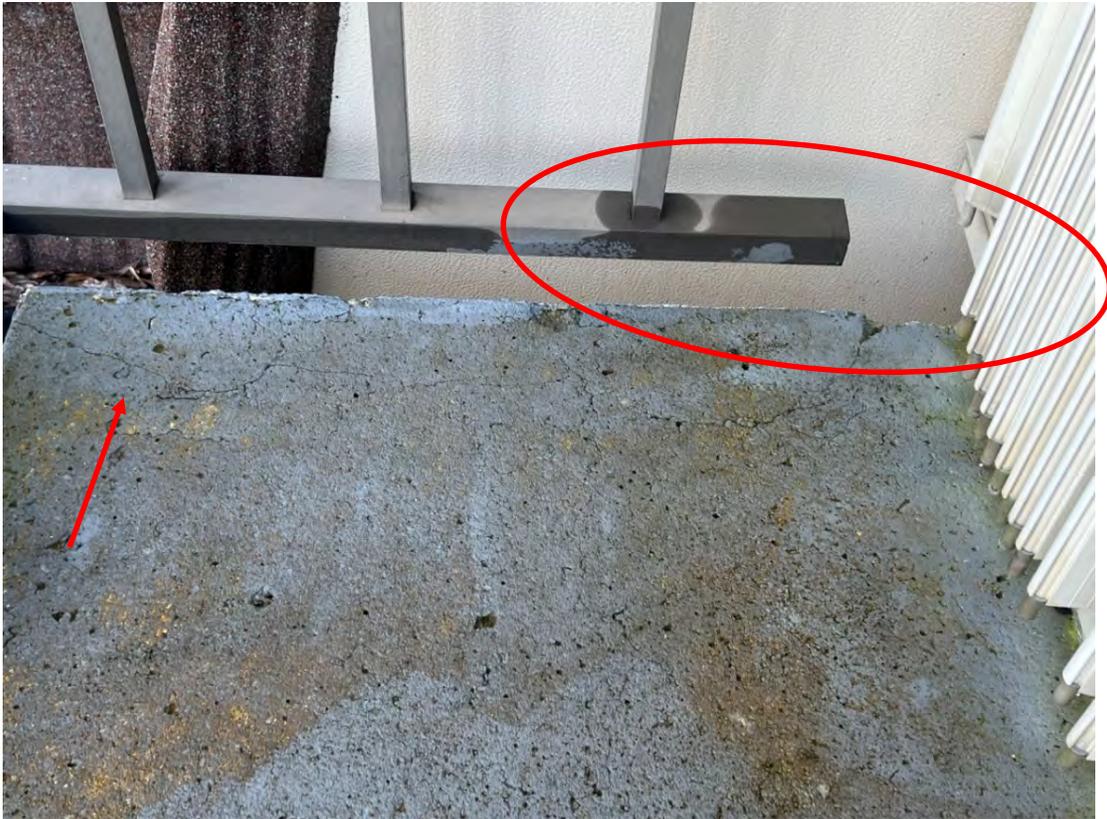
SLAB SPALLS AND CUT/MISSING RAILING, AND BOLT

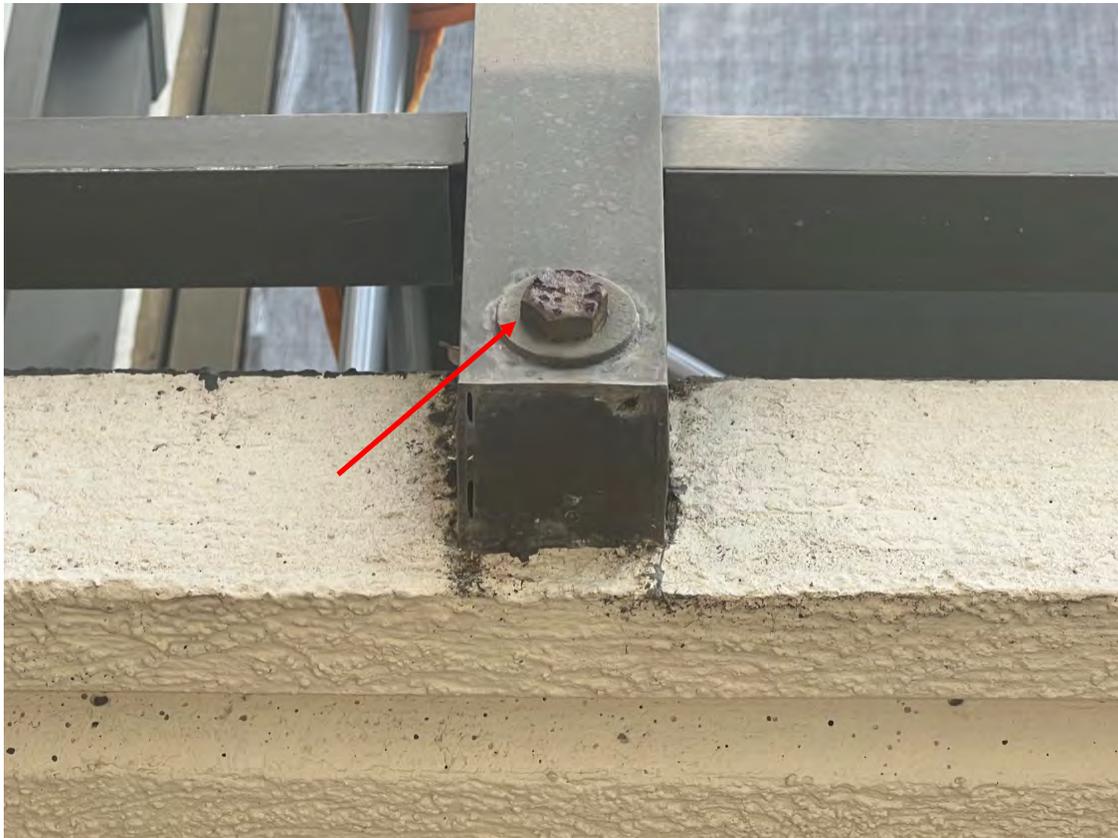
RUSTED BALCONY RAILING BOLTS

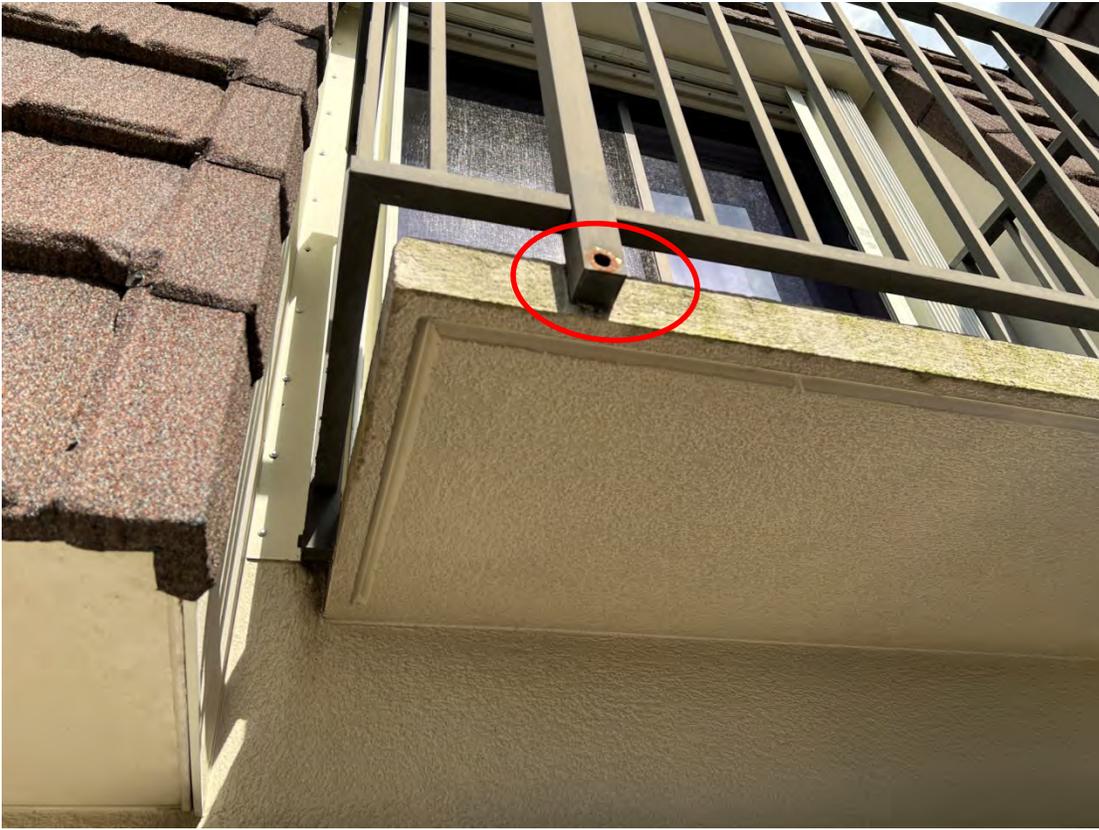
MISSING BALCONY RAILING BOLT

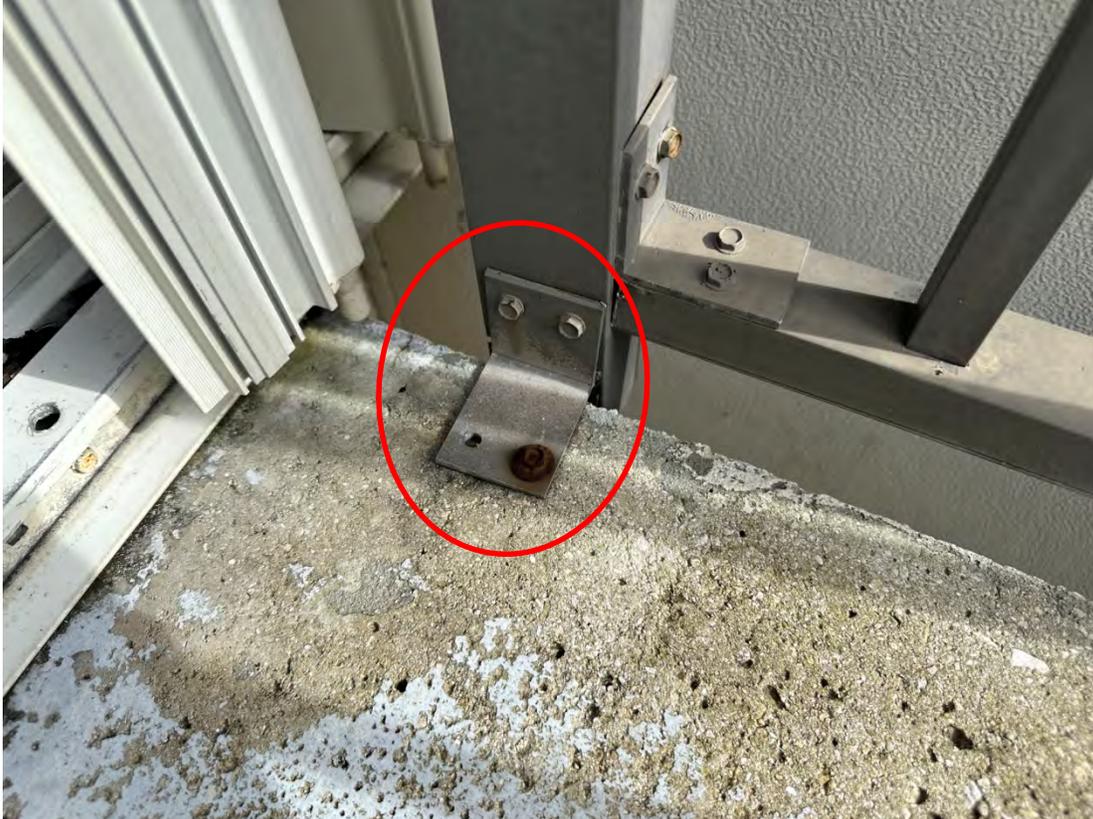
RUSTED AND MISSING BALCONY RAILING FASTENERS

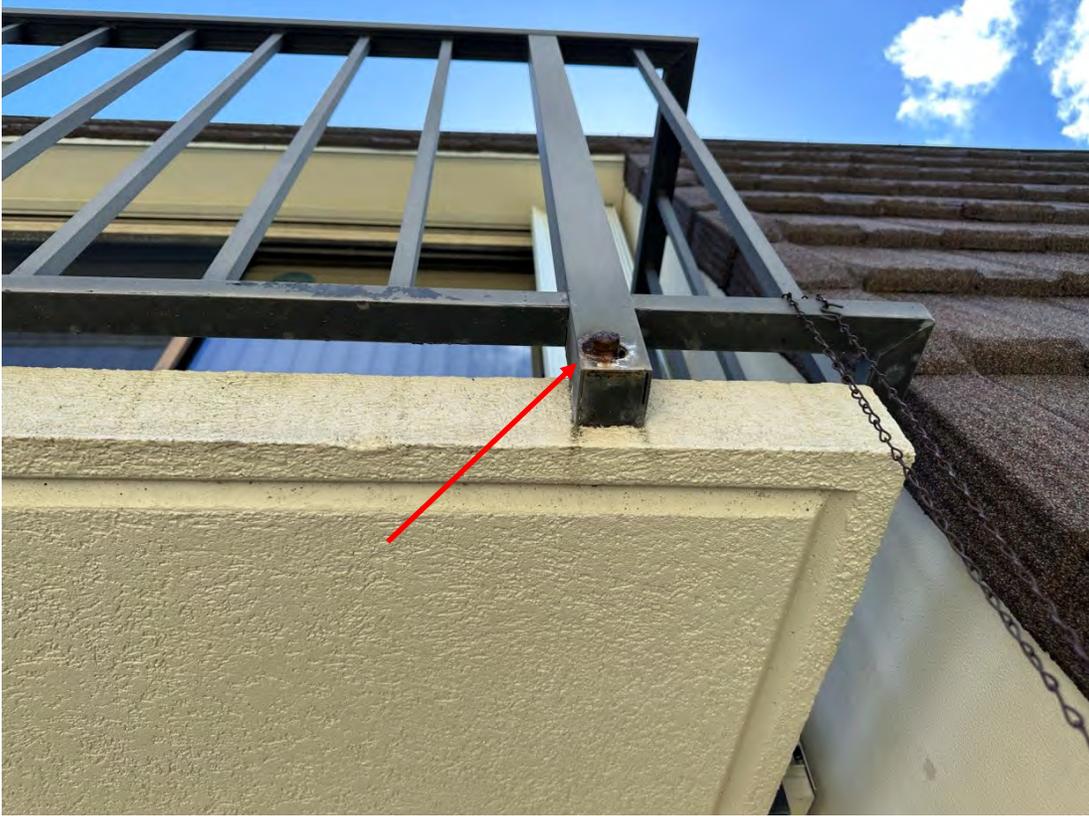
RUSTED / DETERIORATED RAILING POST FASTENER

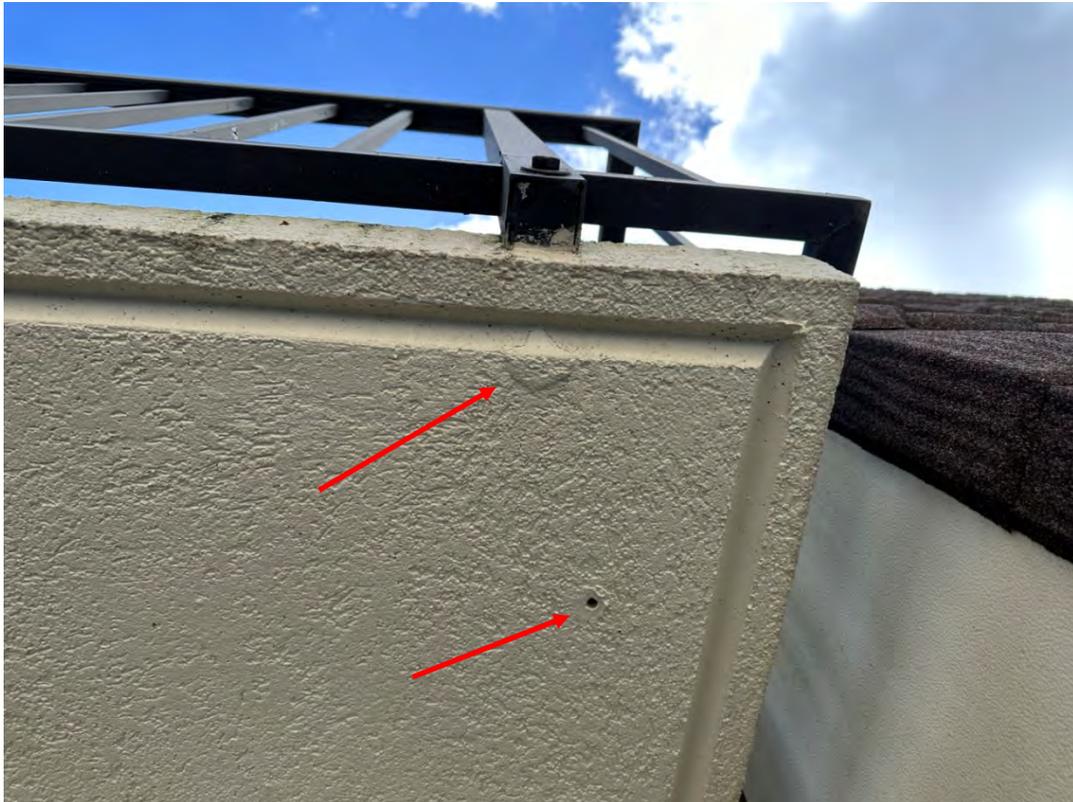
CEILING SPALL UNDER RAILING BOLT, UNUSED FASTENER HOLE

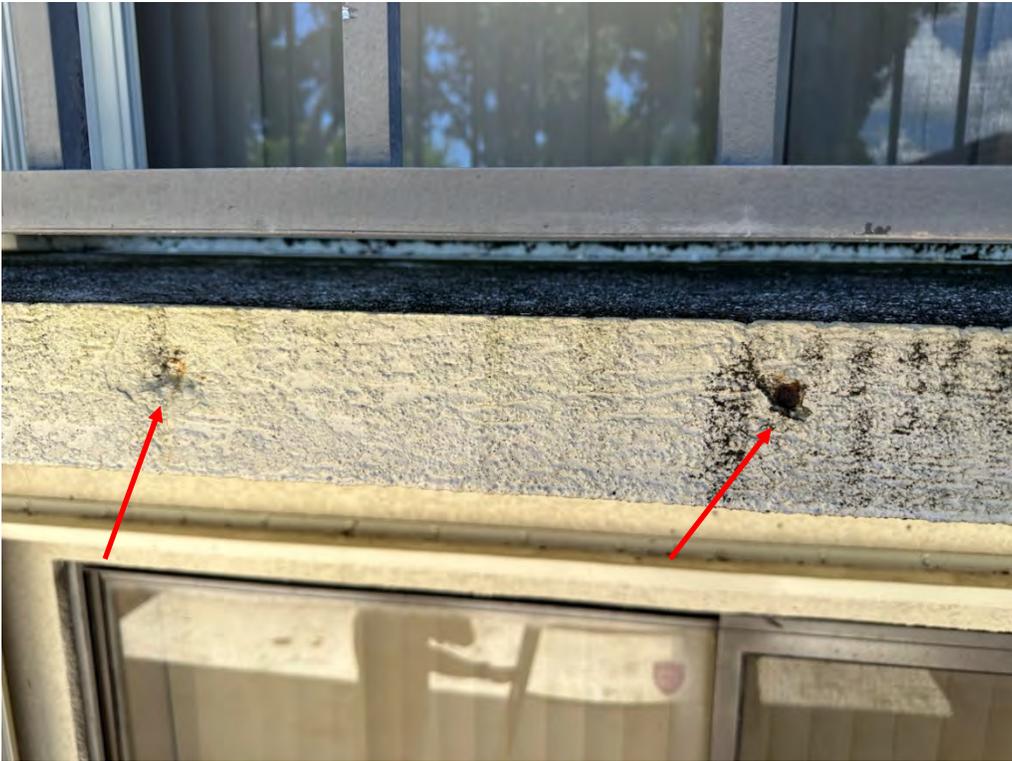
VISIBAL RUSTED REBAR AT BALCONY EDGE

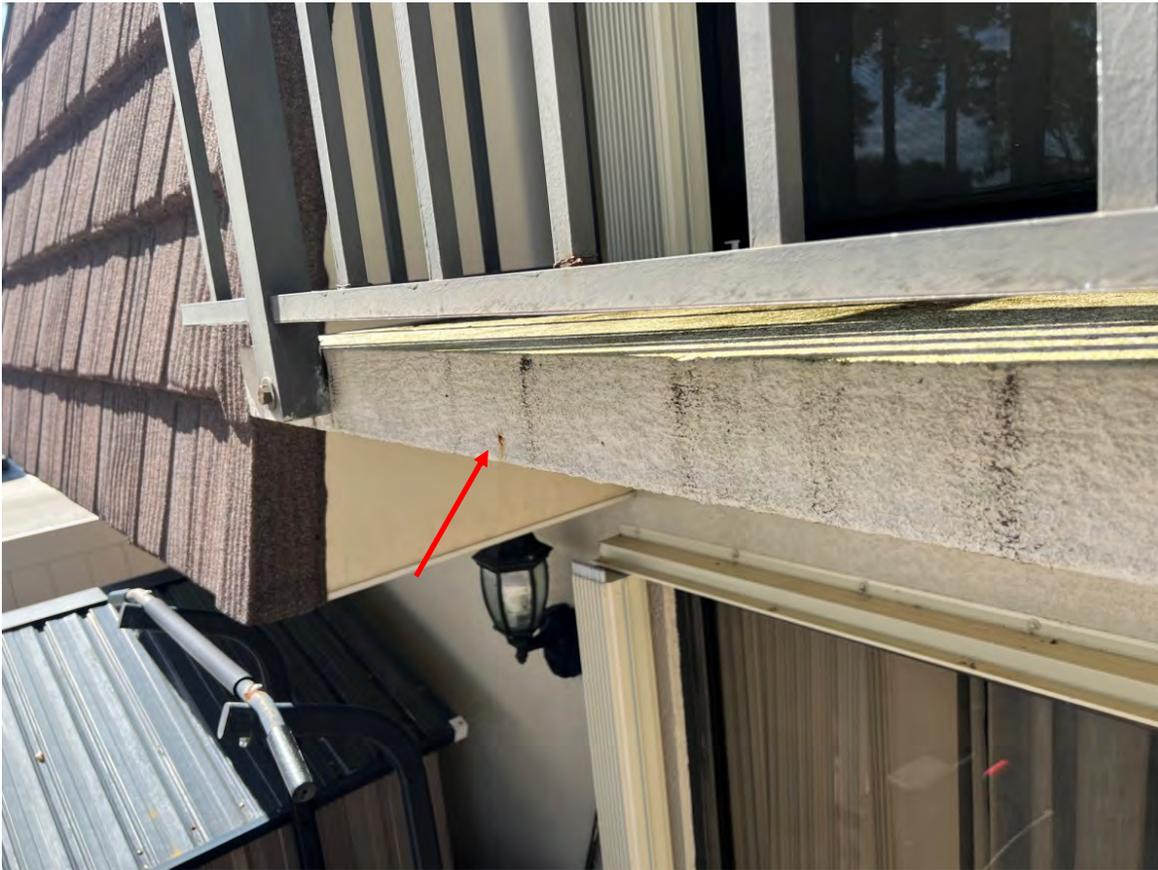
RUST SPOT AT BALCONY SLAB EDGE

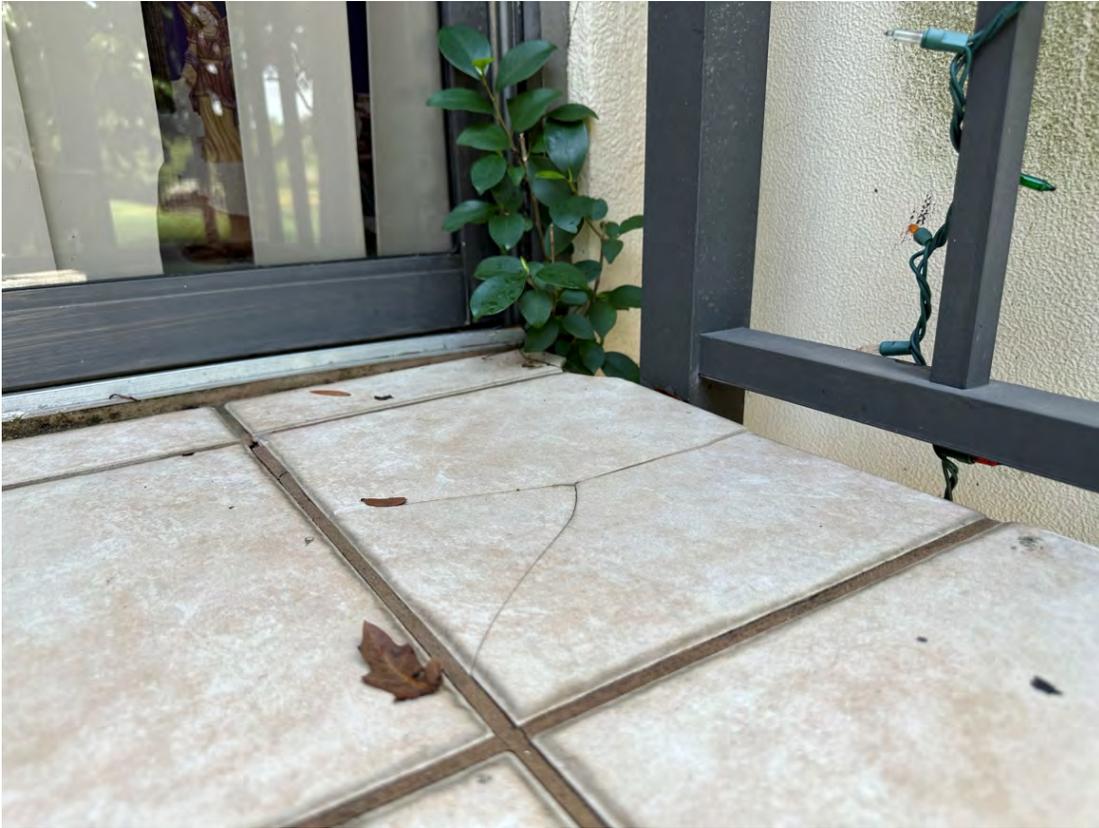
CRACKED AND LIFTED TILE, VEGETATION

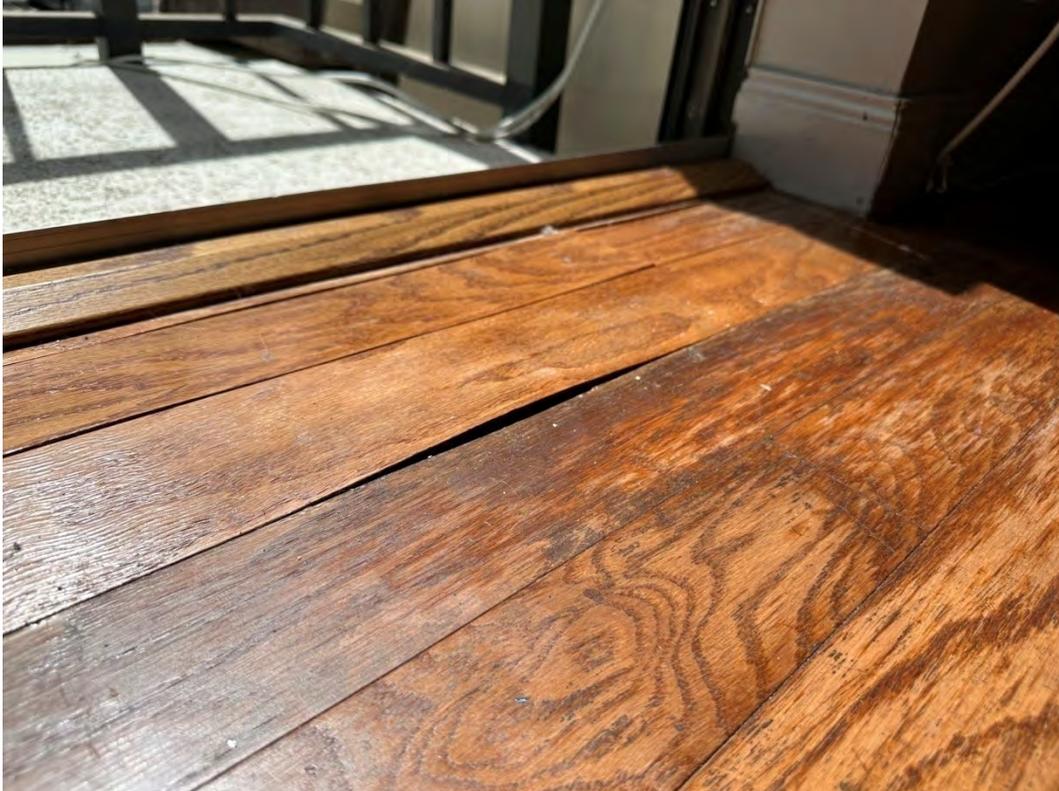
INTERIOR WATER DAMAGE / POSSIBLE SPALL NEAR SGD

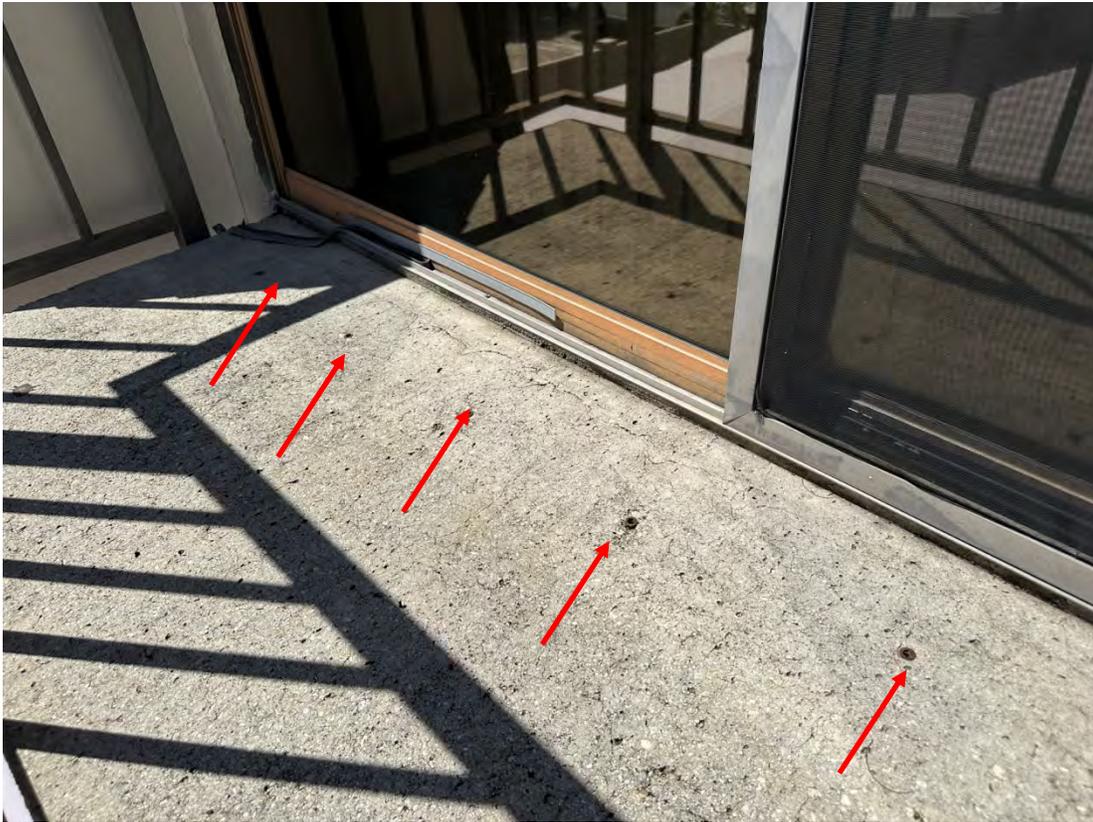
SLAB SPALLS AND UNUSED FASTENERS ON BALCONY SLAB
